# Effectiveness Analysis of An Acid-Based Commercial Cleaner (Harpic) and A Corrosion Inhibitor (Wd-40) on A Motorcycle Fuel Tank

<sup>1,2,3,4,5</sup>Mechanical Engineering, Universitas Riau Kepulauan, Indonesia

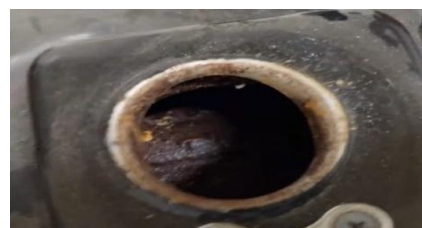
(a) Initial severe corrosion

Figure 4. Comparative visual documentation of the tank's internal surface: (a) Initial severe corrosion, (b) After 72 hours of acid cleaning, (c) Final state after application of corrosion inhibitor.

Prior to any treatment, comprehensive photographic documentation was conducted as specified in the methodology. The visual inspection revealed severe and widespread corrosion affecting approximately 95% of the internal surface area, as shown in Figure 4(a). The initial condition exhibited the following characteristics:

1. Surface Coverage: Near-complete rust coverage (95-100%)
2. Color: Predominantly reddish-brown, consistent with  $\text{Fe}_2\text{O}_3 \cdot n\text{H}_2\text{O}$
3. Texture: Rough, flaky deposits with visible stratification
4. Thickness: Estimated 1-3 mm based on flake dimensions
5. Risk Assessment: High contamination risk for fuel system

The documented condition validated the necessity for restoration, with loose rust particles posing immediate risk of fuel line blockage. Figure 5 provides a detailed close-up view of this severe corrosion.

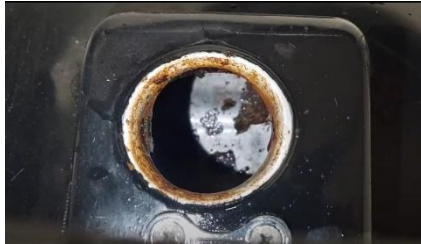
b. After 72 hours of acid cleaning

1. Solution heavily saturated with dissolved iron compounds
2. 90-95% of original rust successfully dissolved
3. Base metal exposed across majority of surface [see Figure 4(b)]
4. Chemical reaction  $\text{Fe}_2\text{O}_3 + 6\text{HCl} \rightarrow 2\text{FeCl}_3 + 3\text{H}_2\text{O}$  confirmed by rust dissolution

- a) 90-95% rust removal achieved
- b) Metallic gray surface exposed
- c) 5-10% residual staining in deep pits
- d) Increased surface roughness noted

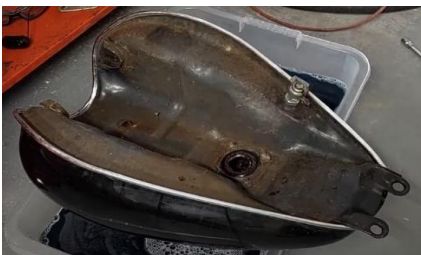
c. Final state after application of corrosion inhibitor

WD-40 application (240 ml) produced immediate visible results, as shown in Figure 4(c):

1. Coverage: Uniform thin film across entire internal surface
2. Visual Indicator: Slight sheen confirming complete coverage

3. Water Displacement: Tested with water droplets - immediate beading observed
4. Adhesion: Film remained stable with no pooling or dripping

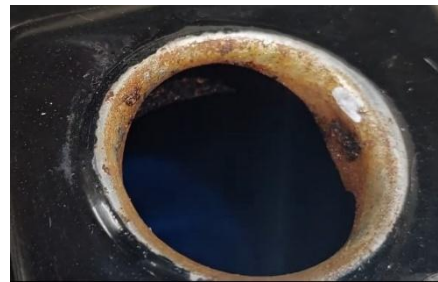
1. Solution color changed from clear to dark brown/black
2. Approximately 40% of surface rust had softened
3. Partial metal exposure in less corroded areas
4. Significant rust remained adhered (60%)

Figure 5. Intermediate rust dissolution stage after 24 hours of acid exposure.

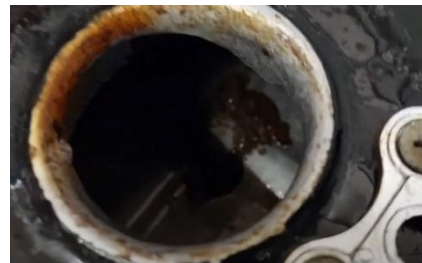
Figure 6. Final corrosion removal result after 72 hours, revealing exposed base metal.

However, the cleaning was not completely uniform. Although the overall condition improved significantly, some residual imperfections remained. Dark gray or black spots were visible in some areas, indicating deep oxidation or reaction byproducts that were not completely rinsed away. Additionally, pinholes and a rougher texture were visible on certain surfaces, most likely related to areas where the initial corrosion was most severe. Despite these minor defects, the process was very effective in removing rust particulates that posed a direct threat to the fuel system. The final state, prior to application of the

Figure 6. Internal surfaces of the tank after 72 hours of acid treatment followed by rinsing and drying with a heat gun. Most of the rust is gone, but there are still some stains left.

The 5-10% residual staining and pitting indicates that some corrosion had progressed beyond simple surface oxidation into the steel substrate. These areas represent locations where rust removal alone cannot restore the original surface integrity.

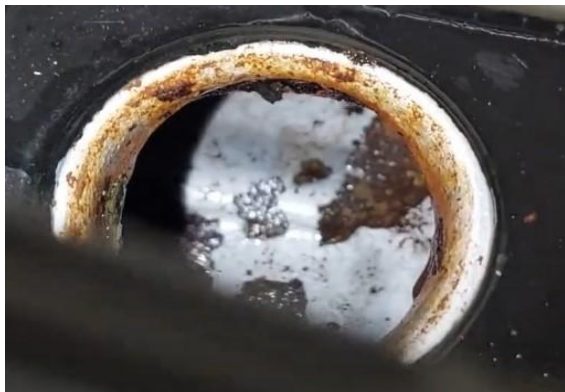
Figure 7 documents the surface condition after one week of protection.

- a) 0% new rust formation
- b) Protective film intact
- c) Metallic appearance maintained
- d) Complete prevention of flash rust

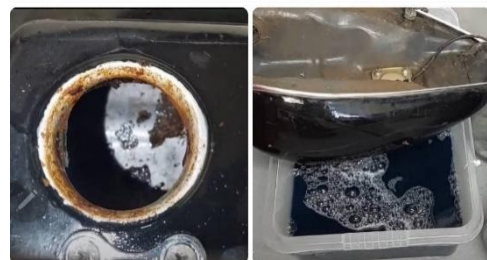
After the initial 24-hour immersion period in the acid-based cleaner, a notable change in the tank's internal condition was observed. The chemical dissolution process was visibly underway, with the top layer of rust beginning to soften and detach from the base metal. This was evidenced by the acidic solution itself becoming discolored and opaque, indicating that iron oxide particles were being successfully suspended within the liquid, as shown in Figure 5.

However, visual inspection confirmed that significant portions of the internal surface remained covered in the original, stubborn rust layer. While the cleaner demonstrated its effectiveness in initiating the rust removal process, this intermediate assessment highlighted that the 24-hour exposure time was insufficient for the complete restoration of the severely corroded tank, justifying the decision to extend the treatment period.

Figure 8. The tank's interior after 24 hours of exposure to the acid cleaner. Partial rust removal is evident, with suspended particles visible in the solution

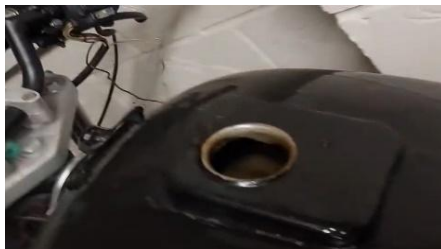
A follow-up inspection was conducted one week after treatment. Observation and analysis of the interior of the tank showed that the surfaces remained clean and free of new rust formation. The metallic luster was maintained, and there was no evidence of the reddish-brown oxidation that typically occurs on unprotected steel exposed to moisture. These results indicate that the application of WD-40 provided effective short-term corrosion protection.

Figure 7. Internal surfaces of the tank one week after coating with corrosion inhibitor. The surfaces remained clean with no evidence of new rust formation.
